**MARYLAND INVENTORY OF
HISTORIC PROPERTIES**

Survey No. BA-2754

and/or common 622 Anneslie Road

7. Description

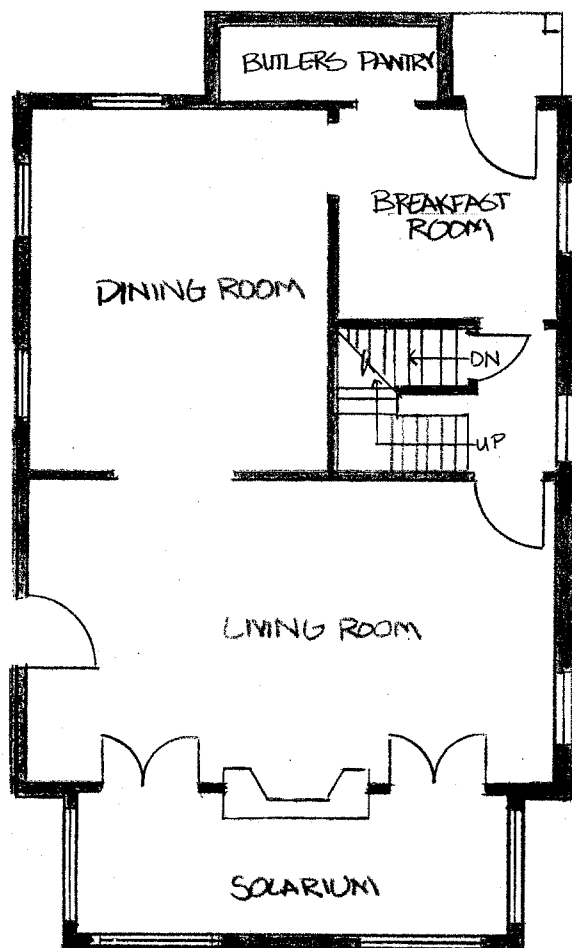
FIRST FLOOR - 622 ANNESLIE ROAD

The floor plan of 622 Anneslie is as unique as the exterior (see Floor Plan). Except for the solarium the plan is a square with the living room off of another room... untill you return to the living room once again (see floor plan 7-5). To the right of the living room is the solarium. To the left is the dining room. Off the dining room is the original breakfast room- now the kitchen. The original butler's pantry, now a pantry, is off the breakfast room. The stair hall connects the breakfast room and the living room. The door to the cellar is in this hall as well.

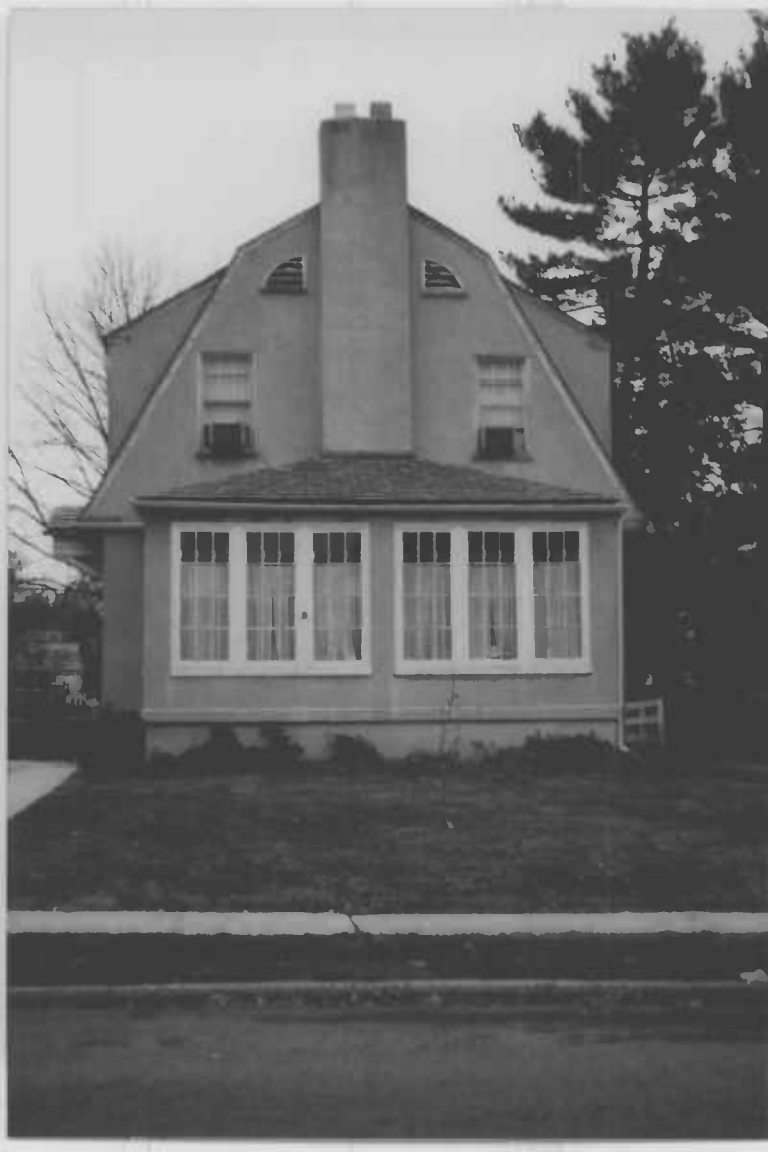
PHOTO: 1 of 5

The primary facade is two bays wide with the chimney stack between them, and faces the street. The main entrance is not on this side (South), most of the architectural interest is on this face. The end of the gambrel roof with shed dormer is on this facade. There is also a solarium with a hipped roof the projects form the entire facade. A projecting chimney is centered over the solarium and continues up the center of this facade. The fenestration on the first level is composed of the windows on South side of the solarium. There are two sets of 3 casement windows with a total of 12 lights centered on this wall. Both the East and West facade of the solarium are composed of one set of three casements windows, exactly the same as on the South facade. The second level has two 6/6 windows equidistant from the chimney. There are also two attic vents on either side of the chimney in a quarter circle shape.

View: South Facade
Facing Street

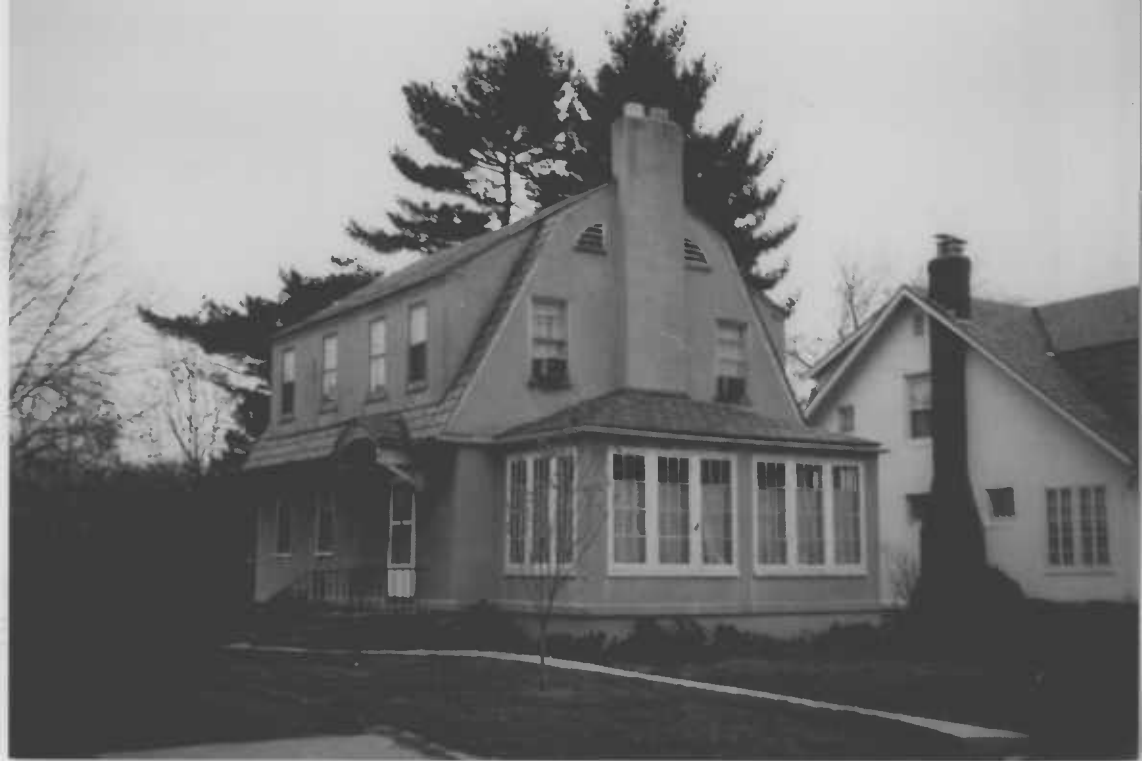
Photo: 2 of 5

The West facade is 3 bays on the first level. This facade has a projecting stucco shed dormer on the second level of the house and the side of the projecting solarium on the right. There is a concrete walkway from the sidewalk to the main door and continuing to the back porch. The front porch is composed of three brick steps. A pedimented porch hood rests on consoles is over the front door. The door has two rows of 4 lights over two beveled panels in the door below. The remaining windows on the first level are two 6/6 windows. The second level has four 6/6 windows in the stucco shed dormer. Two are directly over the

View: South and West
facade
West Facade - main
entrance

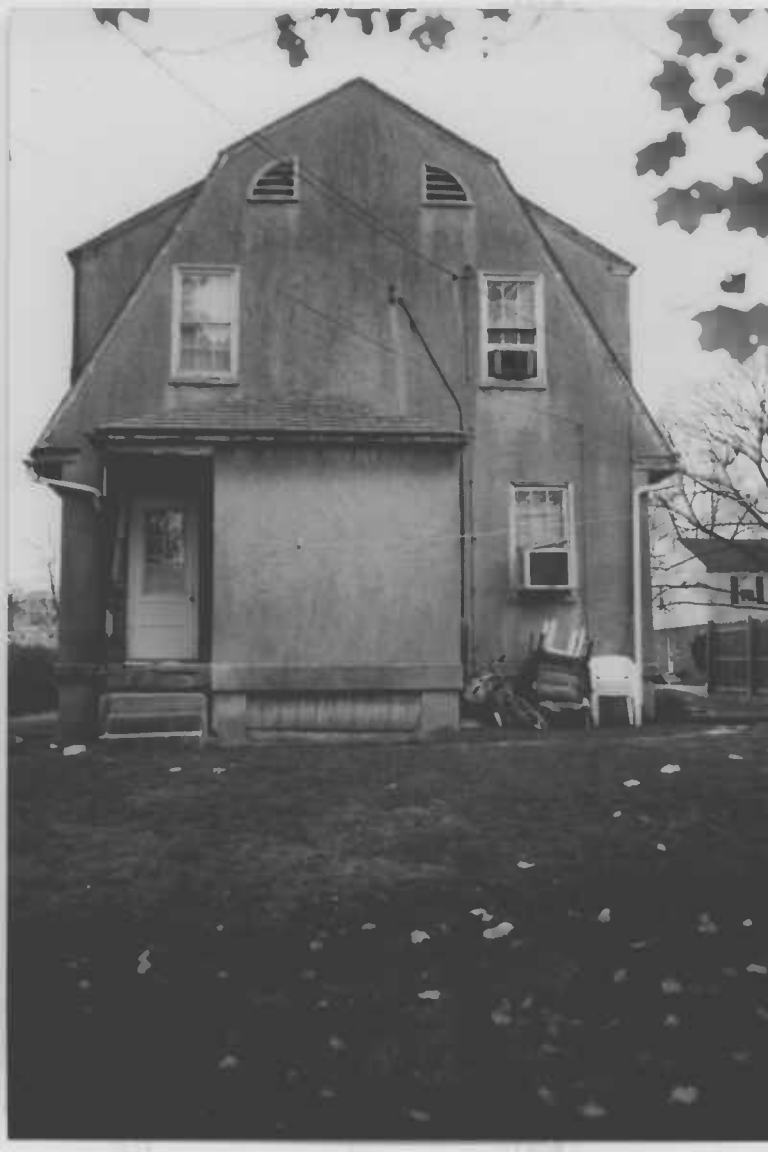
Photo: 3 of 5

The North facade, the back of the house, has one 6/6 window on the right. Then there is a projection with a hipped roof and a covered concrete porch with three steps leading up to the porch to the left. The interior back door has 2/2 window in the upper portion of the door over three small rectangular panes. The East and West end of the projection each has a four light casement window. On the porch there is a door leading to the interior. The second level fenestration and attic ventilation is the same as on the South face (primary facade) of the house. There is a awning window on the cellar level directly under the window on the first level.

View: North Facade
(back of house)

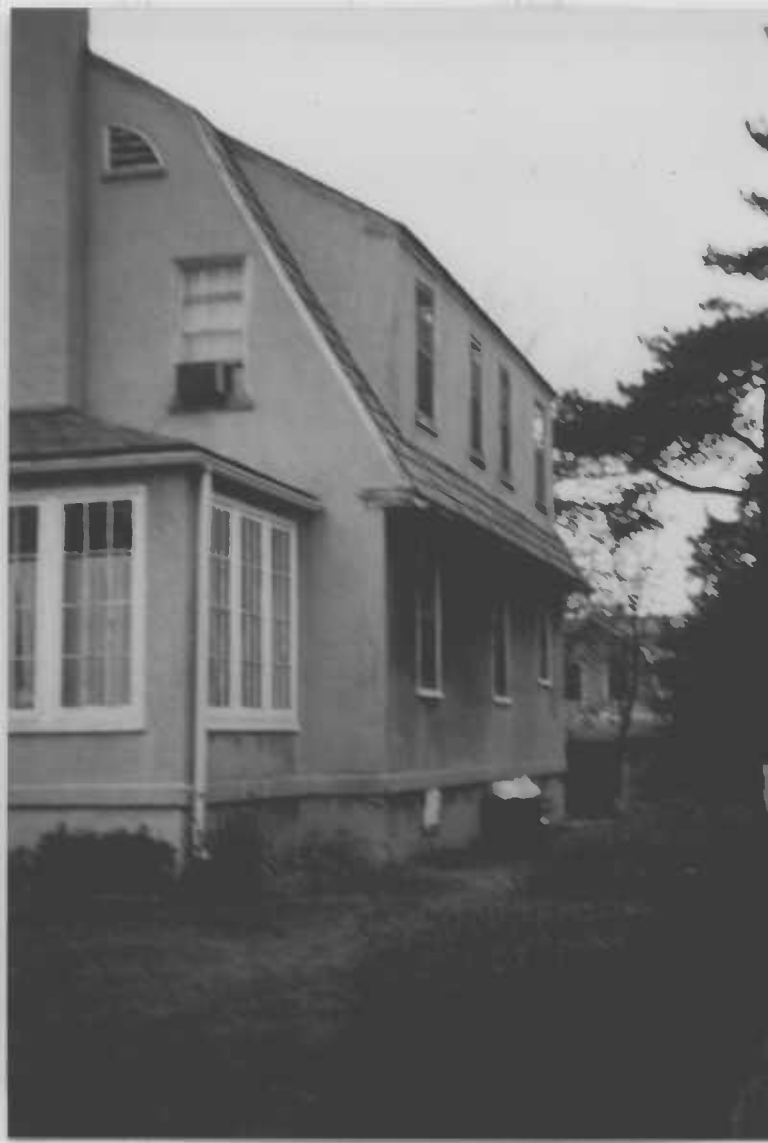
Photo: 4 of 5

The East facade fenestration of the house has one smaller 6/6 window on the right, and two 6/6 windows, all equally spaced on the facade. The second level fenestration is the same as the West facade. The cellar level has two awning windows directly under the center and right window from the first level, and there is a small door/covered opening where the original coal shut was located.

View: Part of South,
and East ~~St~~ Facade

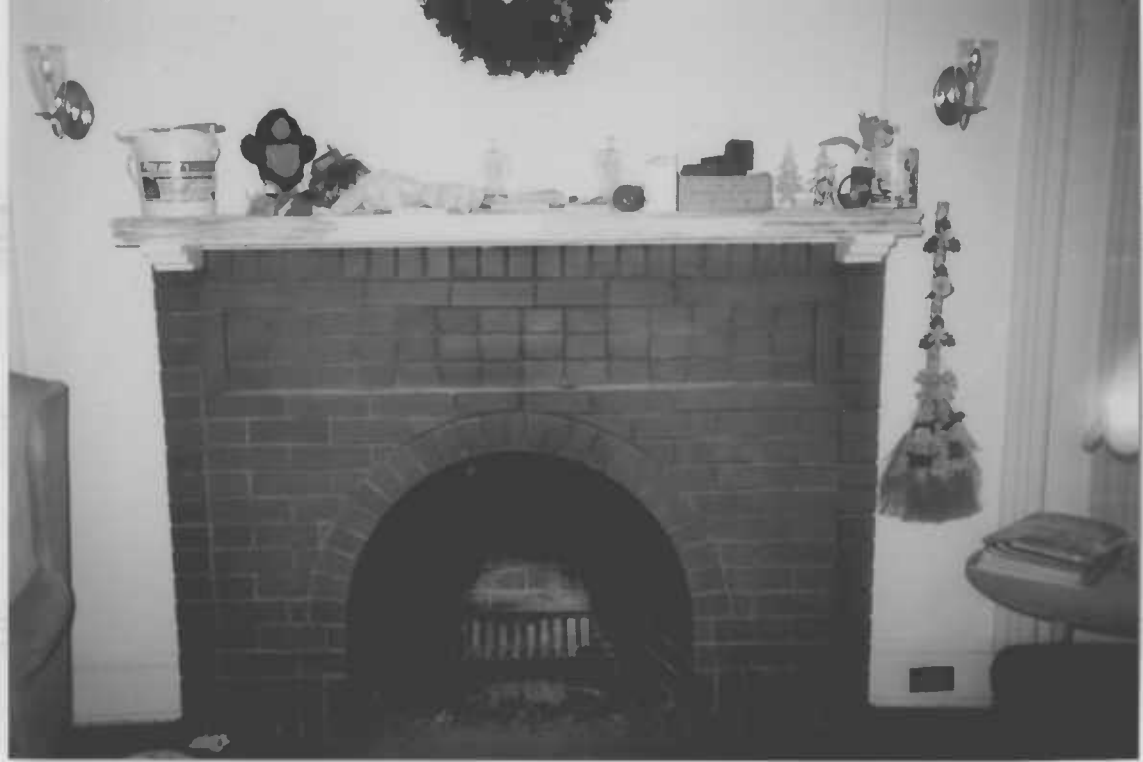
Photo: 50F5

The living room is where the main entrance is located. On the right wall is a brick fireplace centered on the wall with a wood mantle shelf. The brickwork is very elaborate. There is an arch framing the grate. There is an indented brick area over the arch of three

rows of closers. There are stretchers around the entire fireplace. The remaining bricks are in a running bond. The hearth is slate. Flanking the fireplace are two sets of french doors with a total of 10 lights (2 across by 5 high). These doors led to the solarium. There is one window off centered on the wall across from the main entrance. The wall to the left of the door has a 5' framed opening leading to the dining room. Directly next to the far wall is another French door leading to the stair hall. There are a total of 16 lights on the door (2 across by 8 down).

View: Living Room Interior
Fireplace & mantle
